Piston Diagnostics

The process of examining a used piston can tell a mechanic helpful information on the condition of an engine. When an engine failure occurs, the piston is likely to take the brunt of the damage. A careful examination of the piston can help a mechanic trace the source of a mechanical or tuning problem. This technical article serves as a guide for the most common mechanical problems that plague engines.

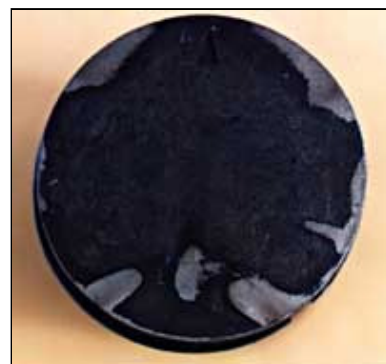
PERFECT BROWN CROWN

The crown of this piston shows an ideal carbon pattern. The transfer ports of this two-stroke engine are flowing equally and the colour of the carbon pattern is chocolate brown. That indicates that this engine's carb is jetted correctly.

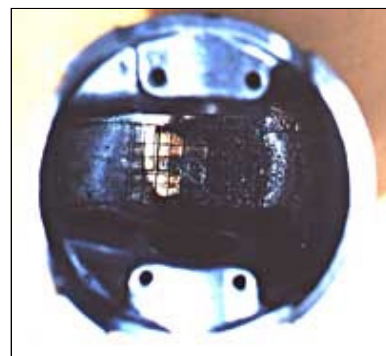
BLACK SPOT HOT

The underside of this piston has a black spot. The black spot is a carbon deposit that resulted from pre-mix oil burning on to the piston because the piston's crown was too hot. The main reasons for this problem are overheating due to too lean carb jetting or coolant system failure.

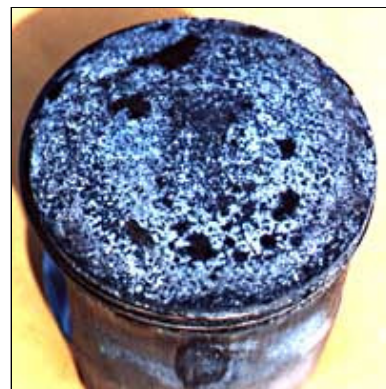
ASH TRASH

This piston crown has an ash colour, which shows that the engine has run hot. The ash colour is actually piston material that has started to flash (melt) and turned to tiny flakes. If this engine was run any longer, it probably would've developed a hot spot and hole near the exhaust side and failed. The main causes of this problem are too lean carb jetting, too hot spark plug range, too far advanced ignition timing, too much compression for the fuel's octane, or a general overheating problem.

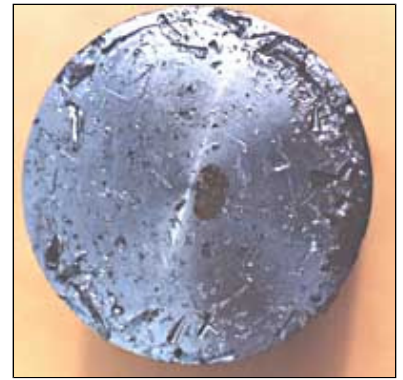
SMASHED DEBRIS

This piston crown has been damaged because debris entered the combustion chamber and was crushed between the piston and the cylinder head. This engine had a corresponding damage pattern on the head's squish band. The common causes of this problem are broken needle bearings from the small or big end bearings of the connecting rod, broken ring ends, or a dislodged ring centring pin. When a problem like this occurs, it's important to locate where the debris originated. Also the crankcases must be flushed out to remove any left over debris that could cause the same damage again. If the debris originated from the big end of the connecting rod, then the crankshaft should be replaced along with the main bearings and seals.

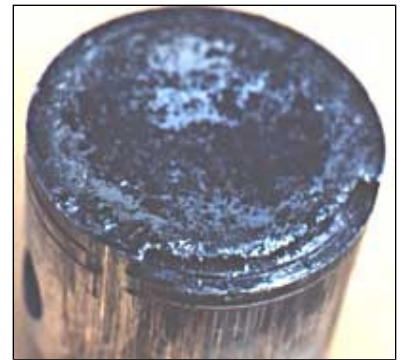
CHIPPED CROWN DROWNED

This piston crown chipped at the top ring groove because of a head gasket leak. The coolant is drawn into the combustion chamber on the down-stroke of the piston. When the coolant hits the piston crown it makes the aluminium brittle and it eventually cracks. In extreme cases the head gasket leak can cause erosion at the top edge of the cylinder and the corresponding area of the head. Minor leaks of the gasket or o-ring appear as black spots across the gasket surface. An engine that suffers from coolant being pressurized and forced out of the radiator cap's vent tube, is a strong indication of a head gasket leak. In most cases the top of the cylinder and the face of the cylinder head must be resurfaced when a leak occurs. Most mx bikes have head stays mounting the head to the frame. Over time the head can become warped near the head stay mounting tab, because of the forces transferred through the frame from the top shock mount. It's important to check for warpage of the head every time you rebuild the top end.

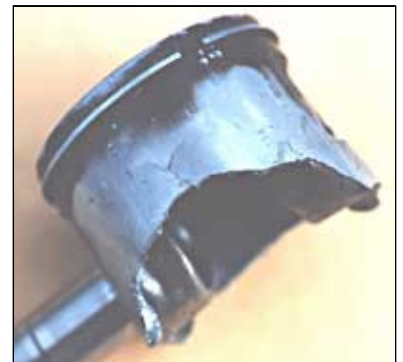
SHATTERED SKIRT

The skirts of this piston shattered because the piston to cylinder clearance was too great. When the piston is allowed to rattle in the cylinder bore, it develops stress cracks and eventually shatters.

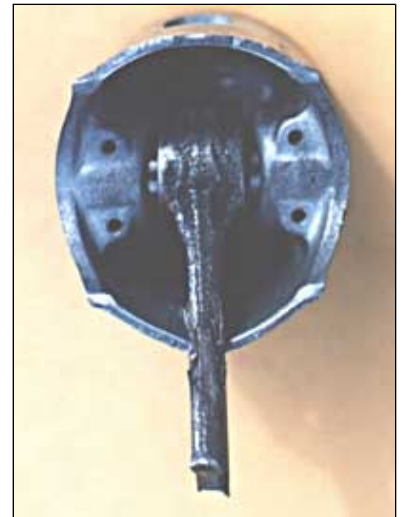
SNAPPED ROD

The connecting rod of this engine snapped in half because the clearance between the rod and the thrust washers of the big end was too great. When the big end bearing wears out, the radial deflection of the rod becomes excessive and the rod suffers from torsion vibration. This leads to connecting rod breakage and catastrophic engine damage. The big end clearance should be checked every time you rebuild the top end. To check the side clearance of the connecting rod, insert a feeler gauge between the rod and a thrust washer. Check the maximum wear limits in your engine's factory service manual.

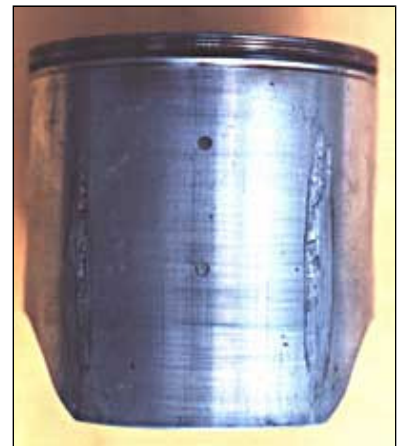
FOUR-CORNER SEIZURE

This piston has vertical seizure marks at four equally spaced points around the circumference. A four-corner seizure is caused when the piston expands faster than the cylinder and the clearance between the piston and cylinder is reduced. Another common problem of this type is a single point seizure on the centre of the exhaust side of the piston. However this occurs only on cylinders with bridged exhaust ports. The main causes for this problem are too quick warm-up, too lean carb jetting (main jet), or too hot of a spark plug range.

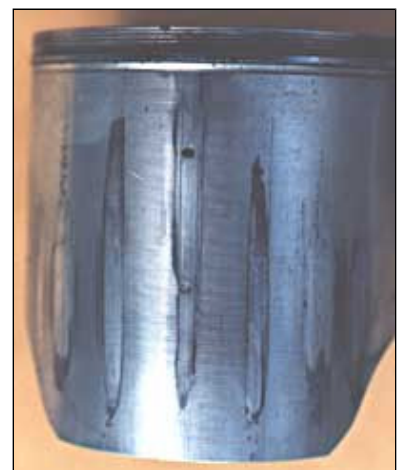
MULTI-POINT SEIZURE

This piston has many vertical seizure marks around the circumference. This cylinder was bored to a diameter that was too small for the piston. As soon as the engine started and the piston started its thermal expansion, the piston pressed up against the cylinder walls and seized. The optimum piston to cylinder wall clearances for different types of cylinders vary greatly. For example a 50cc composite plated cylinder can use a piston to cylinder wall clearance of .0015 inches, whereas a 1200cc steel-sleeved cylinder snowmobile set-up for grass drags will need between .0055 to .0075 inches. For the best recommendation on the optimum piston to cylinder clearance for your engine, look to the specs that come packaged with the piston or consult your factory service manual.

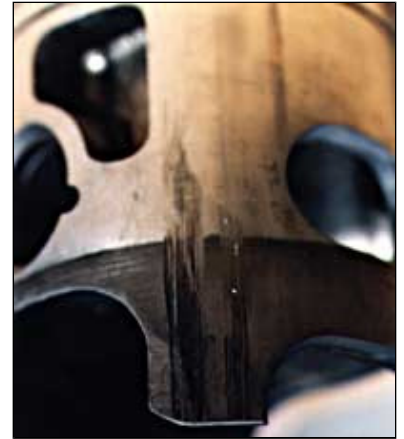
INTAKE SIDE SEIZURE

This piston was seized on the intake side. This is very uncommon and is caused by only

one thing, loss of lubrication. There are three possible causes for loss of lubrication, no pre-mix oil, separation of the fuel and pre-mix oil in the fuel tank, water passed through the air-filter and washed the oil film off the piston skirt.

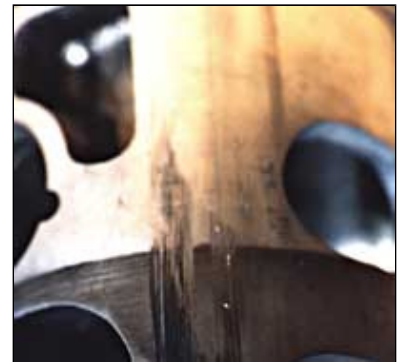
COMPOSITE FLAKING

Most two-stroke cylinders used on motorcycles and snowmobiles, have composite plated cylinders. The composite material is made of tiny silicon carbide particles. The electro-plating process enables the silicon carbide particles to bond to the cylinder wall. The particles are very hard and sharp, they don't bond to the ports so the manufacturer or reconditioning specialist must thoroughly clean the cylinder. Sometimes the silicon carbide "flashing" breaks loose from the ports and becomes wedged between the cylinder and the piston. This causes tiny vertical scratches in the piston. This problem isn't necessarily dangerous and doesn't cause catastrophic piston failure, but it should be addressed by thoroughly flushing the cylinder and ball-honing the bore to redefine the cross-hatching marks. Normally you will need to replace the piston kit because the scratches will reduce the piston's diameter beyond the wear spec.

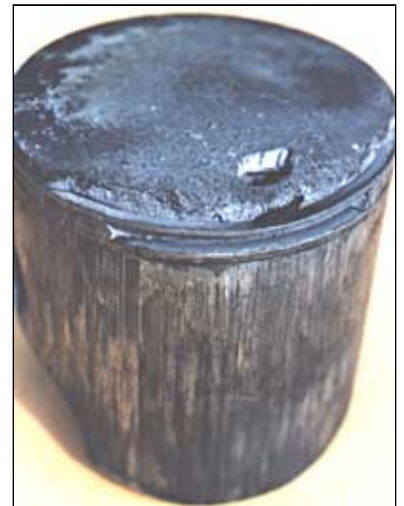
BURNT-OUT BLOW-HOLE

This piston was overheated so badly that a hole melted through the crown and collapsed the ring grooves on the exhaust side. Normally the piston temperature is higher on the exhaust side so catastrophic problems will appear there first. There are several reasons for a failure like this, here are the most common; air-leak at the magneto side crankshaft seal, too lean carb jetting, too far advanced ignition timing or faulty igniter box, too hot of a spark plug range, too high of a compression ratio, too low octane fuel.

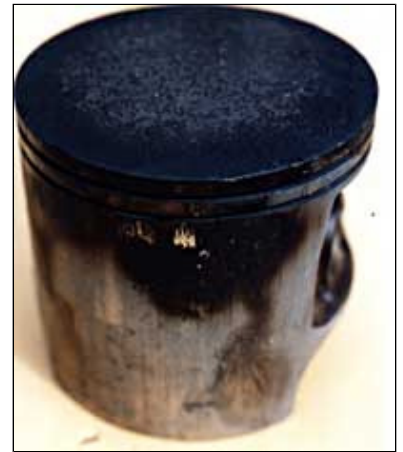
BLOW-BY

This piston didn't fail in operation but it does show the most common problem, blow-by. The rings were worn past the maximum ring end gap spec, allowing combustion

pressure to seep past the rings and down the piston skirt causing a distinct carbon pattern. Its possible that the cylinder walls cross-hatched honing pattern is partly to blame. If the cylinder walls are glazed or worn too far, even new rings won't seal properly to prevent a blow-by problem. Flex-Hones is a product available at most auto parts stores. They can be used to remove oil glazing and restore cross-hatch honing marks that enable the rings to wear to the cylinder and form a good seal. If you purchase a Flex-Hone for your cylinder, the proper grit is 240 and the size should be 10% smaller than the bore diameter.
